ZETA-THREE

TECHNICAL BULLETIN #1

Time Code Reader Input Improvement

November 15, 1988

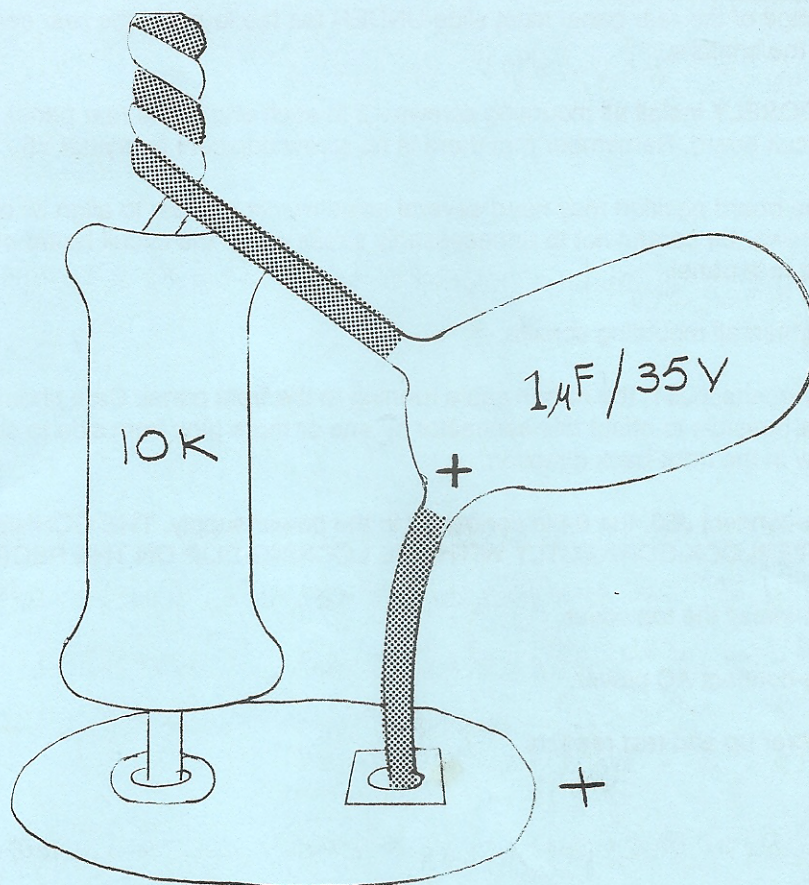
FIG 1

Under some circumstances, the Time Code Reader inputs of some Zeta Three's in the field have shown a tendency to fail when exposed to sharp transients.

The usual symptom of the problem is that one of the Zeta readers stops reading time code completely. A secondary symptom is that the reader may continue to function, but only if excessively high Time Code levels are sent to it.

NOTE: THE "+" SIGNS PRINTED ON THE ZETA CIRCUIT BOARD ARE VERY MISLEADING, AND SHOULD BE IGNORED.
THE POSITIVE LEAD OF THE CAPACITOR MUST BE SOLDERED INTO THE SQUARE PAD, WHILE THE RESISTOR IS SOLDERED INTO THE ROUND PAD.
SEE FIG 1.

To replace capacitors C54 (Master reader) and C24 (Slave reader) each with an identical resistor/capacitor network.

10. Prepare two resistor/capacitor networks. Each is constructed by twisting together one lead of a 10K resistor and the NEGATIVE lead of a 1μF/35volt capacitor. The twisted leads should be soldered and the excess clipped off. (See Fig 1)
11. Install and solder one each of these networks in capacitor positions C54 and C24 as shown in Fig 1.
